UNITED STATES ENVIRONMENTAL PROTECTION AGENCY
REGION 5
77 WEST JACKSON BOULEVARD
CHICAGO, IL 60604

SUBJECT: INSPECTION REPORT – West Bay Exploration Co., Jackson County, Michigan

Facility: Norvell 27 CTB, Norvell Township

Date of Inspection: August 28, 2014

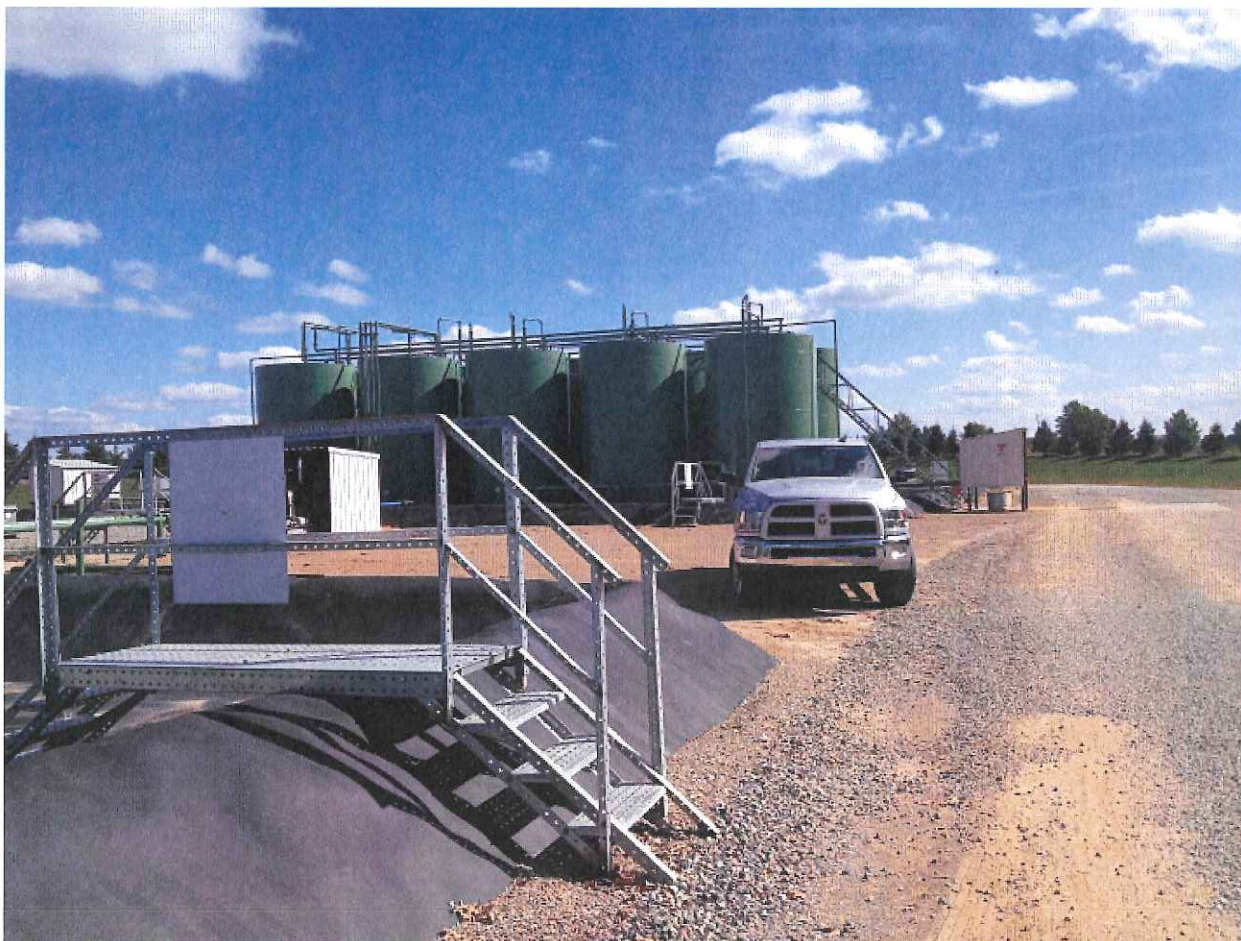
I began my tour at the tank battery. Upon climbing the stairs to the tops of the tanks, I used the IR camera (a FLIR GF320) to take video clips of leaking tank thief hatches. Hatches on four of the eight oil tanks and both brine tanks were leaking continuously (see IR Camera Video log).

1) Tank battery.

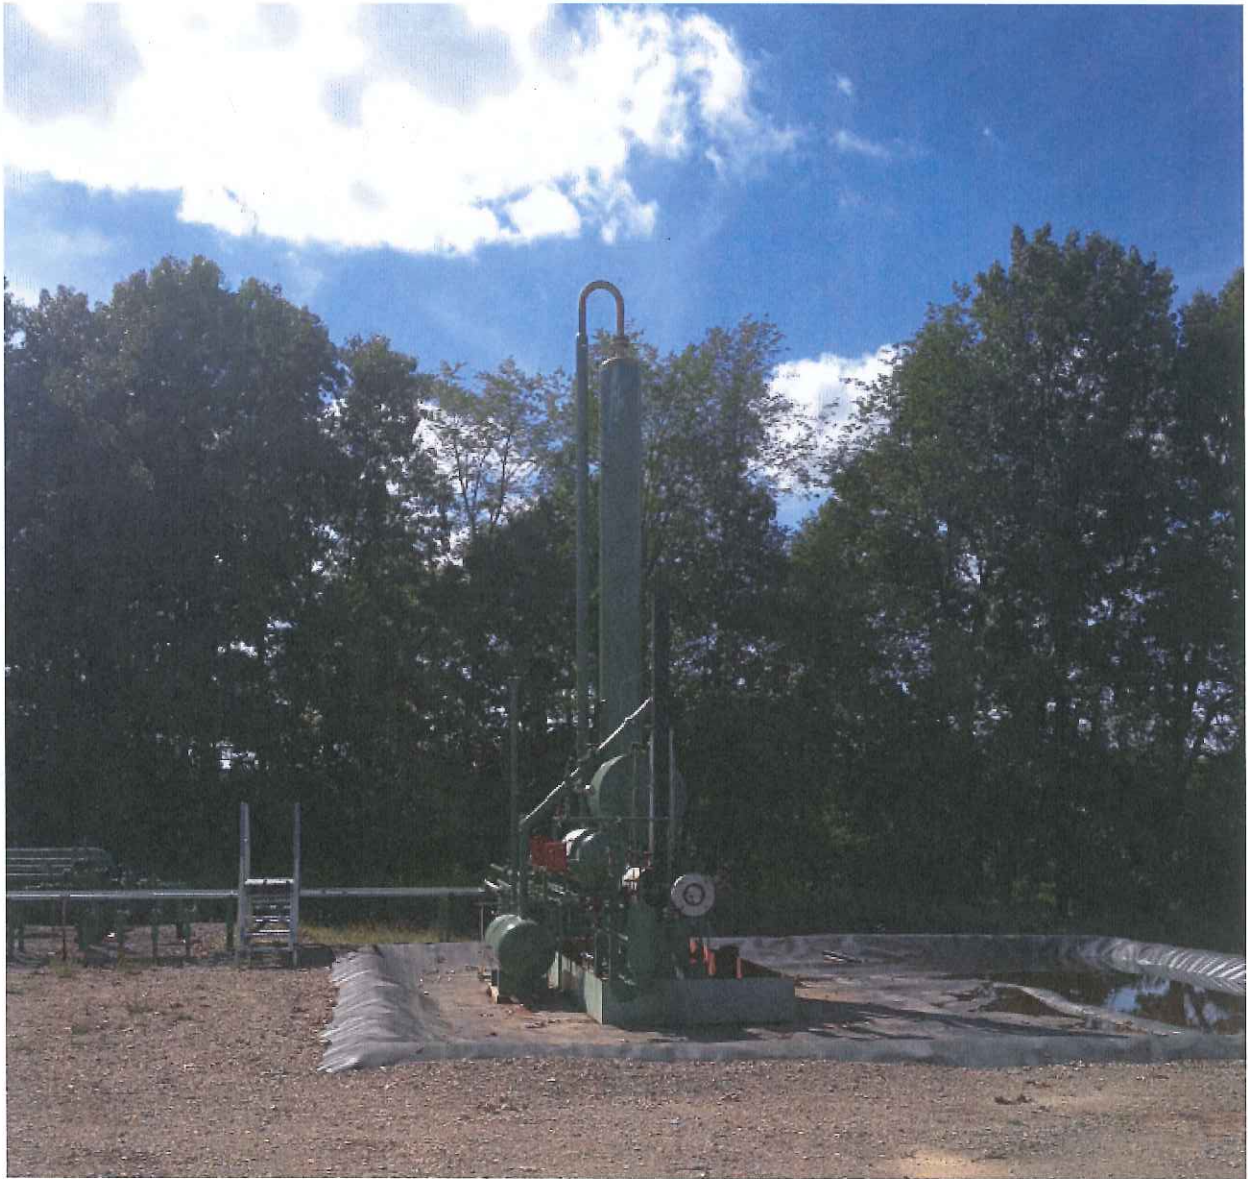
I also took two IR video clips of the flare, one from the top of the tank battery and one from ground level nearer the flare. The flare was lit throughout the duration of the inspection and I did not note any visible emissions (with the naked eye) from the flare. The IR video clips show a gas plume moving beyond the combustion zone of the flare. I briefly viewed the glycol dehydrator with the IR camera and did not noted any leaks.

2) Glycol dehydrator.

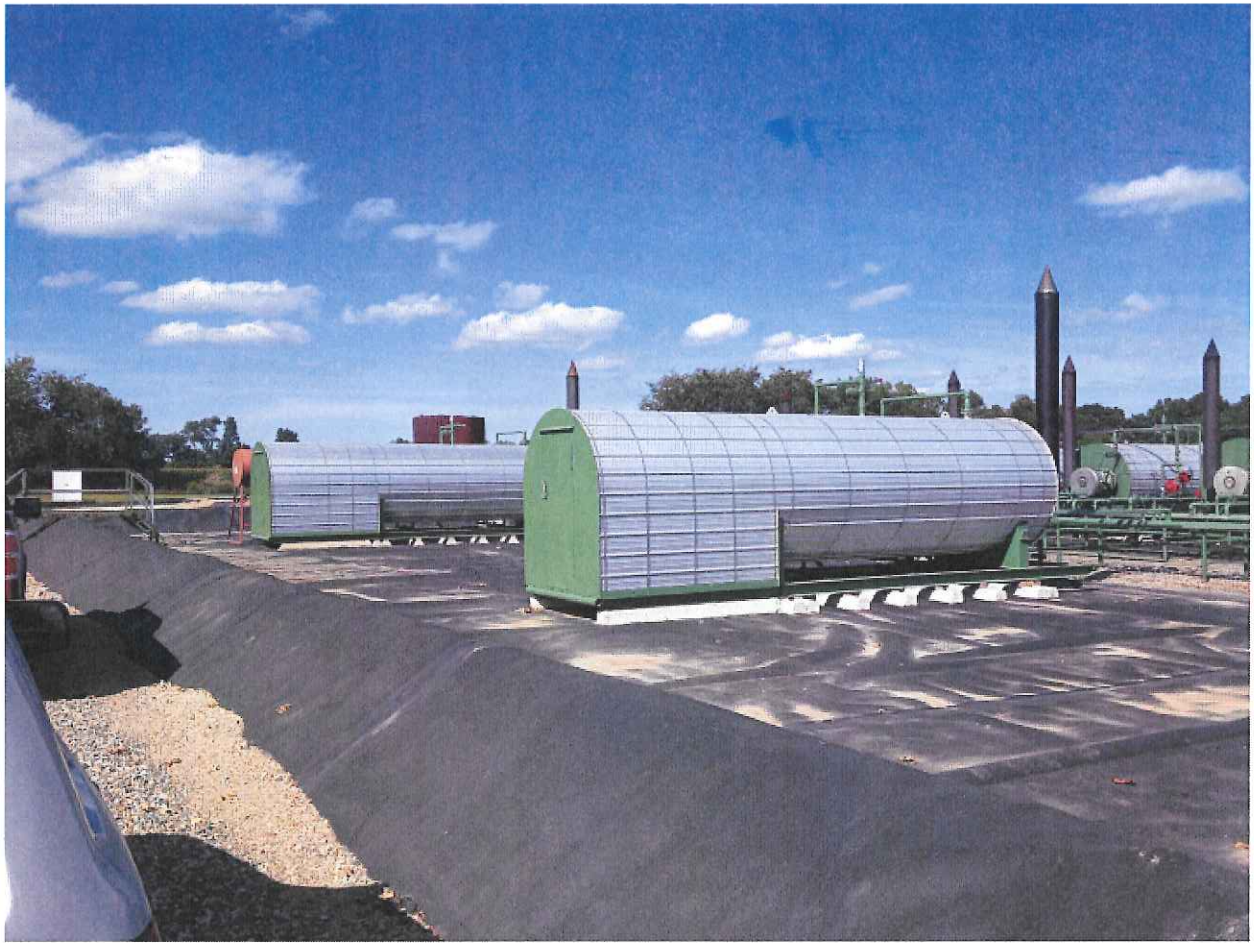
3) Heater treaters with flare in background.
